Creep Testing for Polystyrene_NPS_QLD_225

for Superslab Tech Pty Ltd

7 November 2011

Project No: 2010001465

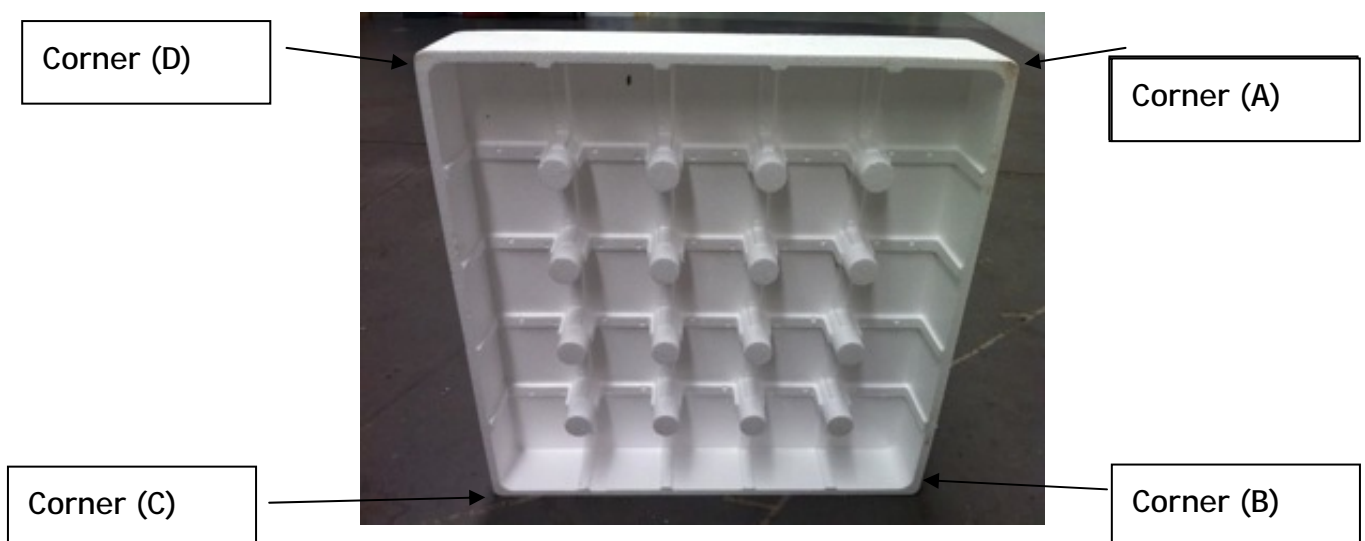
The configuration of the Polystyrene (1090 mm x 1090 mm x 225 mm) are shown in Figure 1

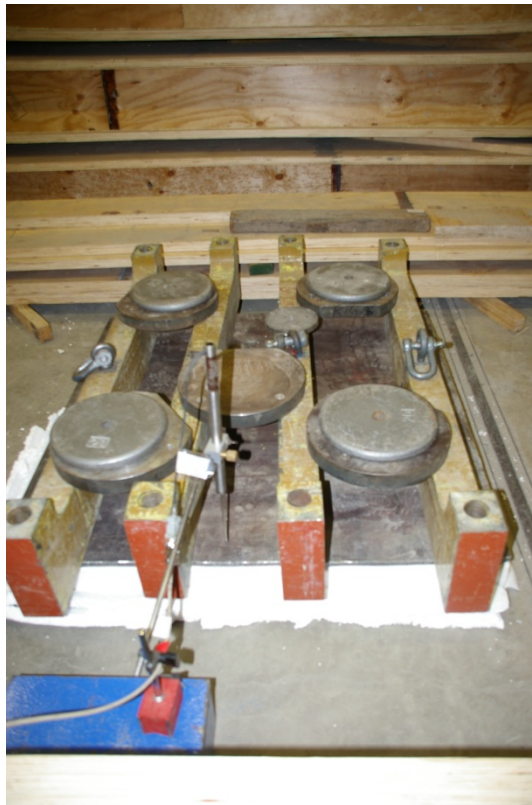
The NPS_QLD_225_CR0001 was placed onto a flat surface and was loaded with 800 kg of dead load as shown in Figure 2. The corresponding displacement data (The stroke) was monitored on digital displays and also sampled by the data logging equipment. The logged data was stored on a computer for post test processing. The product was loaded till a complete failure had occurred.

Figure 2 - Set up of the test
