Interaction between Katana bored pile foundation and ground beam in residential applications

***Executive Summary:** This report investigated the interaction between the Katana screw pile and the soffit of a concrete ground beam in the construction of low-rise housing foundations. It aimed to determine the implications of the removal of a slab plate on manufacturing, site installation and structural detailing of the support concrete ground beam. This was achieved through a practical and theoretical investigation into the drive nut and concrete ground beam interaction. The removal of the slab plate saves materials and costs which add up to a significant amount over the application of hundreds of piles across a site. This would allow Katana Foundations to set a more competitive pricing that will benefit themselves and consumers. Moreover, the resulting reduction in steel reduces the embodied emissions of the screw pile system, an environmental benefit felt by the consumers and the wider community. The investigation compared the theoretical and experimental failure mechanisms at several locations along the beam to determine the extents of which the interaction satisfies the safe work

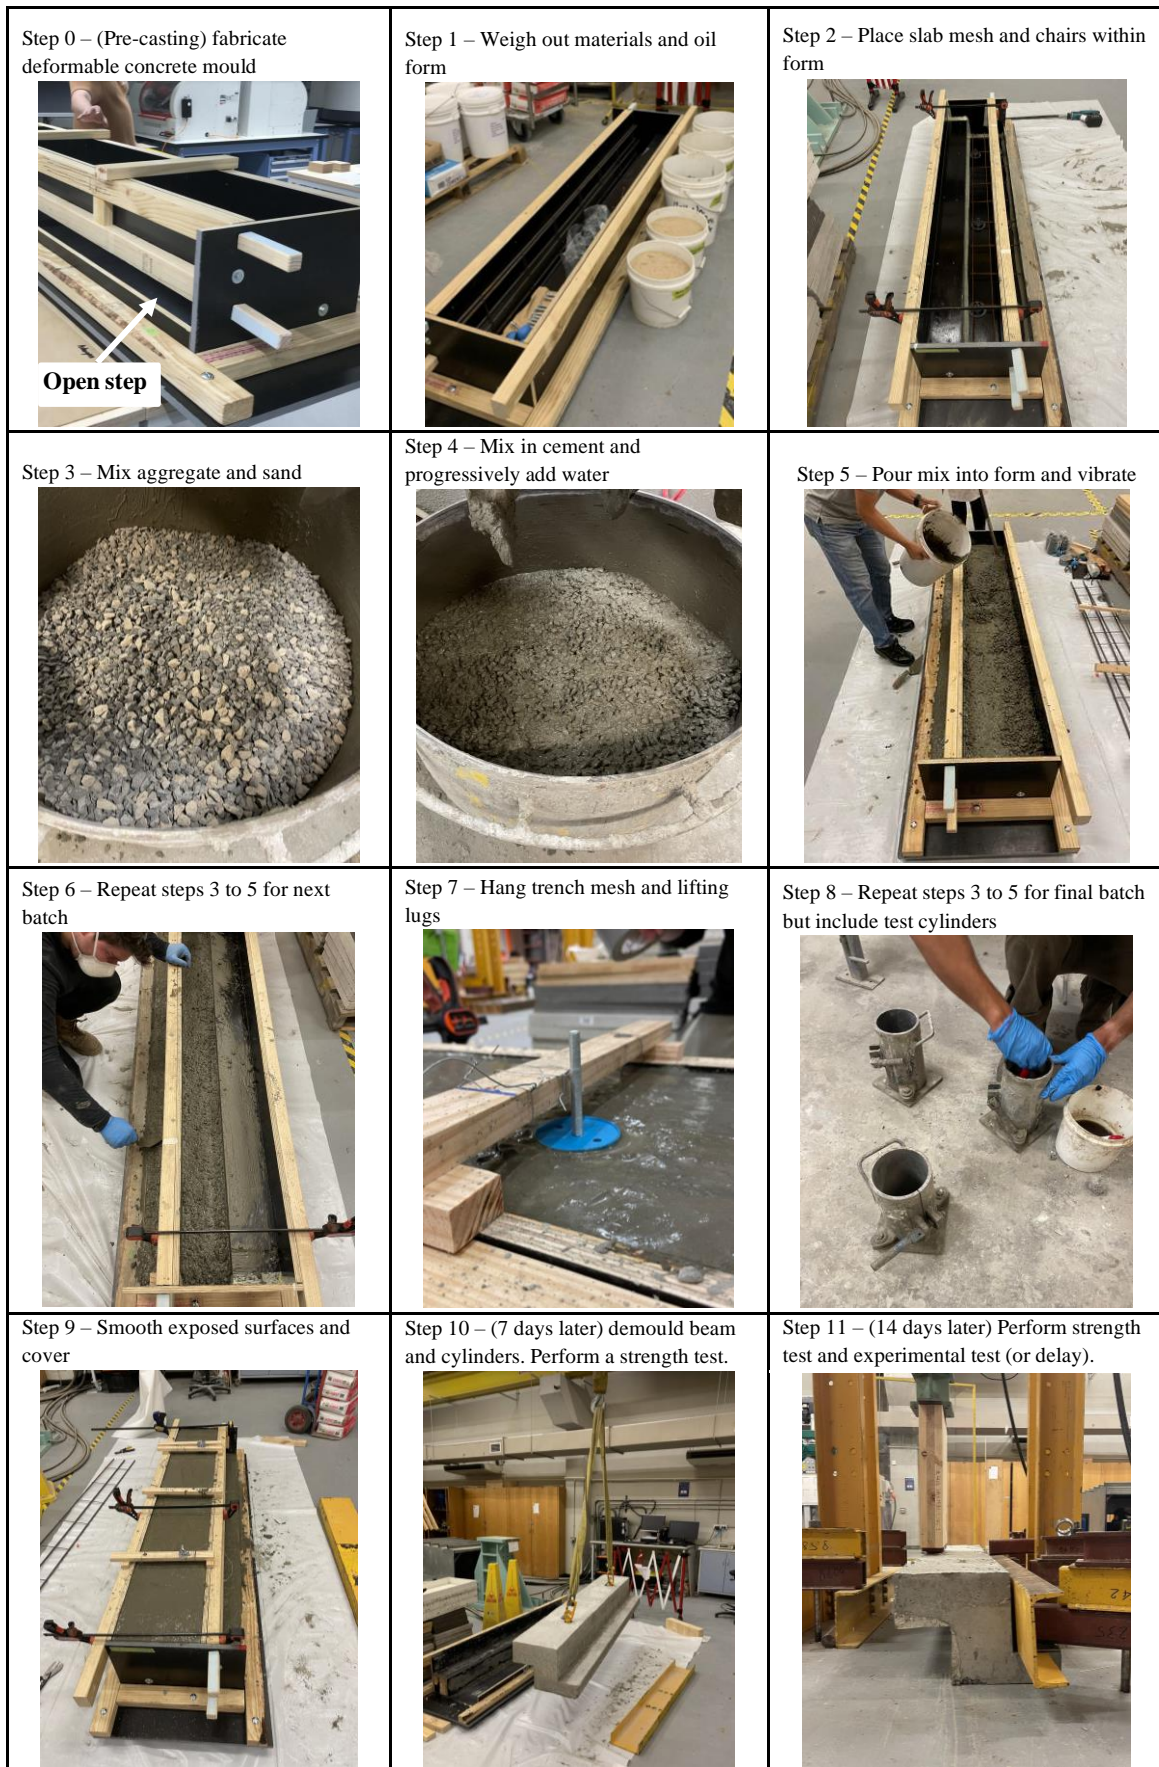
Figure 4. Concrete casting

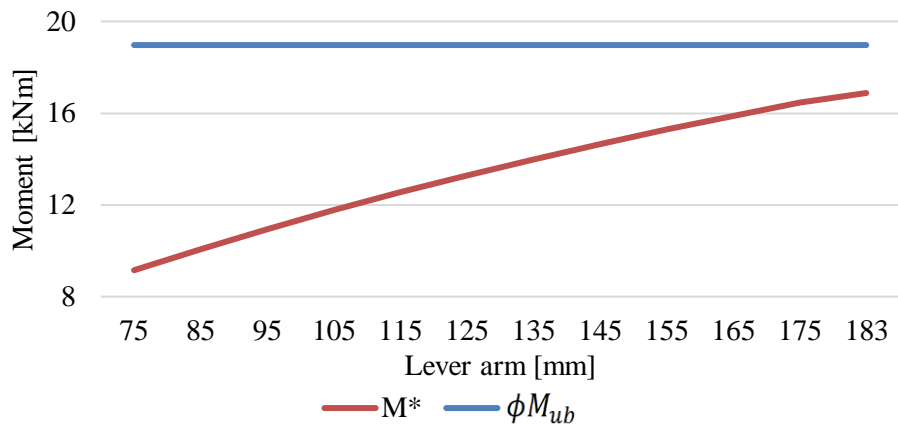
The concrete beam, with a length of 2000 mm between piles, is not expected to fail in flexure as $M^* < \phi M_{ub}$ (18.97 kNm) at the applied force at which punching shear failure is expected, as proven in Figure 16.

Figure 16. Moment capacity and design moment graphic

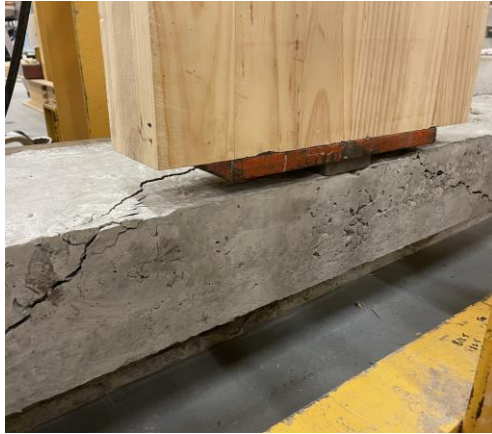
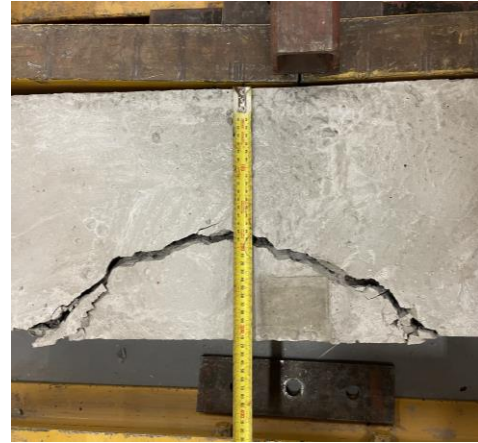
The first test (test 1) positioned the drive nut at a maximum eccentricity of 107.5 mm offset from the beam centre. The beam was tested at 14 days maturity and recorded a concrete strength of 16.09 MPa which was averaged from two concrete cylinder samples. As the actuator loaded the beam the rate of loading was reduced to observe the failure mechanism in the beam more closely. The beam reached a yield force of 69.44 kN before experiencing punching shear failure (illustrated in Figure 17) at an ultimate force of 69.60 kN, as shown in Figure 18. No flexural cracks or other failure was observed prior to the shear failure.

Figure 17. Test 1 observed failure

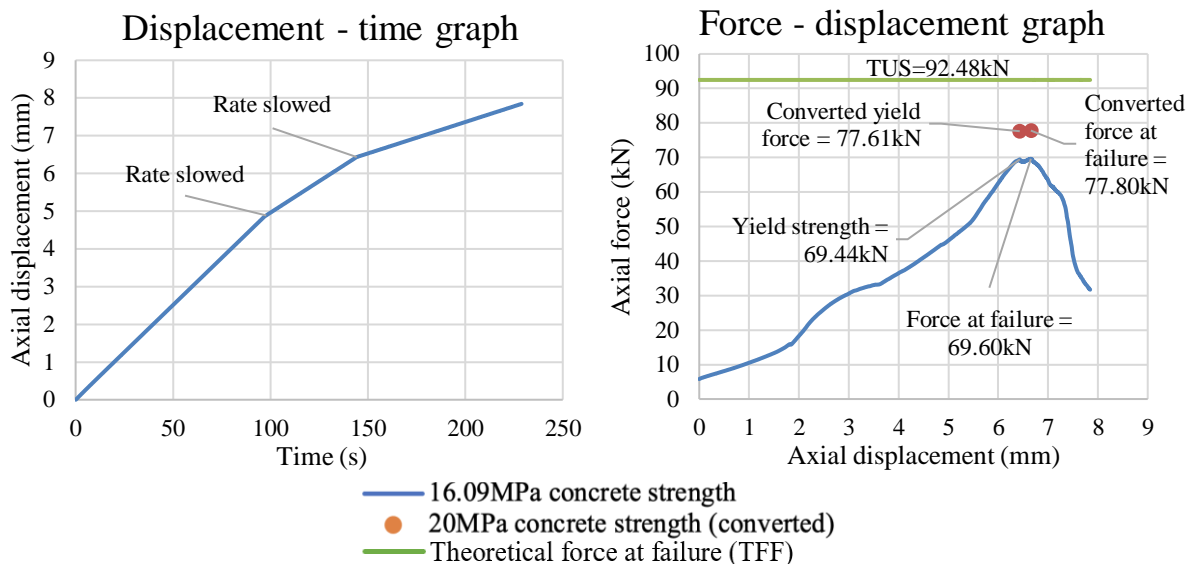
Figure 18. Test 1 (107.5mm) graphical data

As the strength of the beam was below the desired concrete strength for testing [20 MPa], the ultimate strength value was scaled to account for the reduced concrete strength. The scaled failure force of the beam for an equivalent beam of 20 MPa strength was determined to be 77.80 kN. The results of test 1 show that a pile with a drive nut attachment, which is installed at maximum eccentricity from the beam centre, does not have capacity to bear the SWL load of the pile and will fail in punching shear.

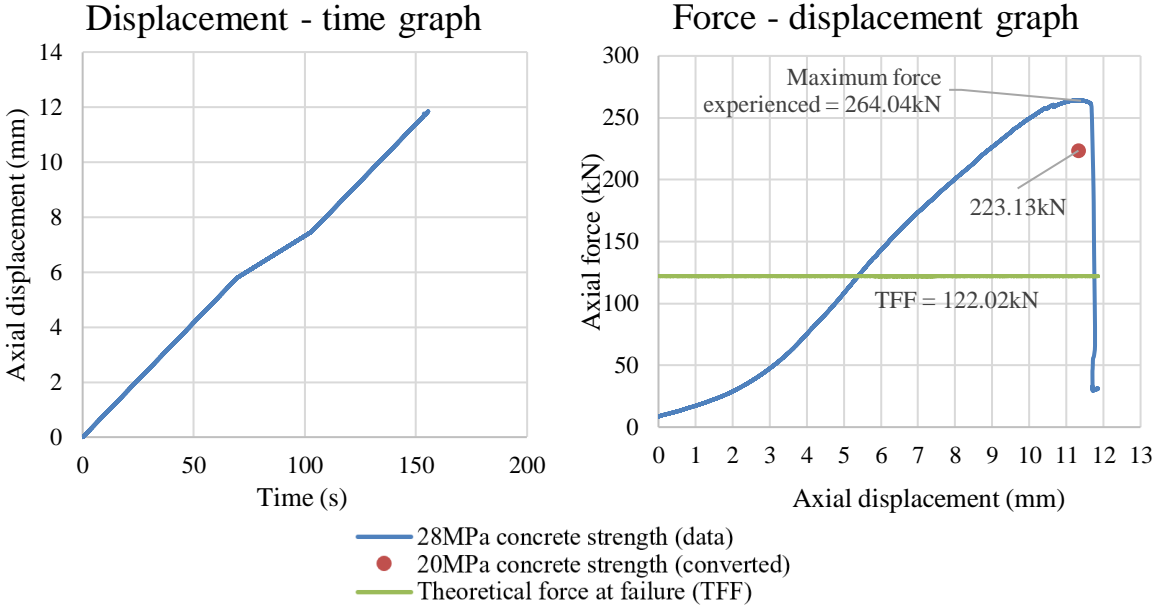
Figure 20. Test 2 (no eccentricity) graphical data

Accounting for the high strength of the test cylinders, the adjusted maximum force experienced by the beam of 223.13 kN is well above expectations. This proves that when the screw pile is centrally located, the drive nut provides a sufficient cap end to achieve a favourable strength and needs of the system (SWL [80 kN] < 223.13 kN).

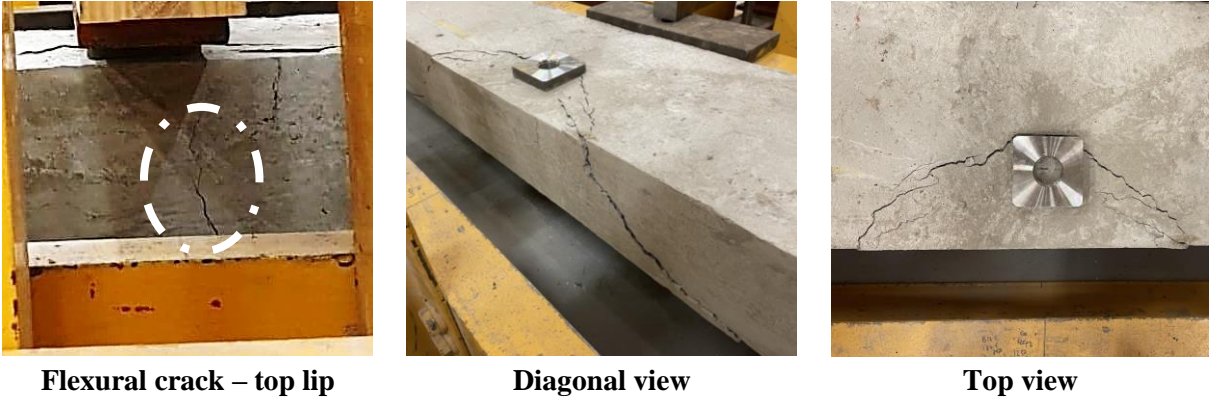
failure force is reached beyond this through punching shear failure (corrected data - 97.67 kN), illustrated in Figure 21. The observed failure indicates that the drive nut is a sufficient pile end at a 53.75 mm displacement from the center line (SWL [80 kN] < 97.67 kN).

Figure 21. Test 3 observed failure

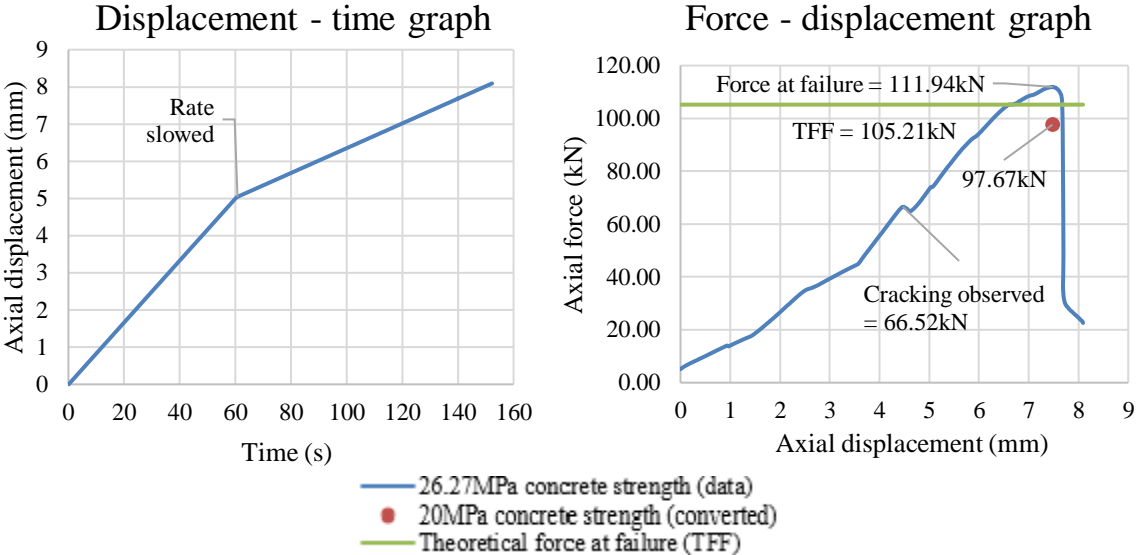
Similarly, to test 2, a vertical flexural crack was observed in test 3, explaining the local maximum on the force-displacement graph at 66.52 kN in Figure 22. The crack started forming around 60 kN in line with the axial load and slowly propagated up the beam. The loading rate was reduced here to carefully observe this crack. It is believed to be the result of voids between the aggregate, creating a weak point in the beam. The rate of the curve is similar before and after the local maximum, indicating the crack has had minimal impact on the beams ability to bear load. The influence of this is ignored as the

Figure 22. Test 3 (53.75mm) graphical data

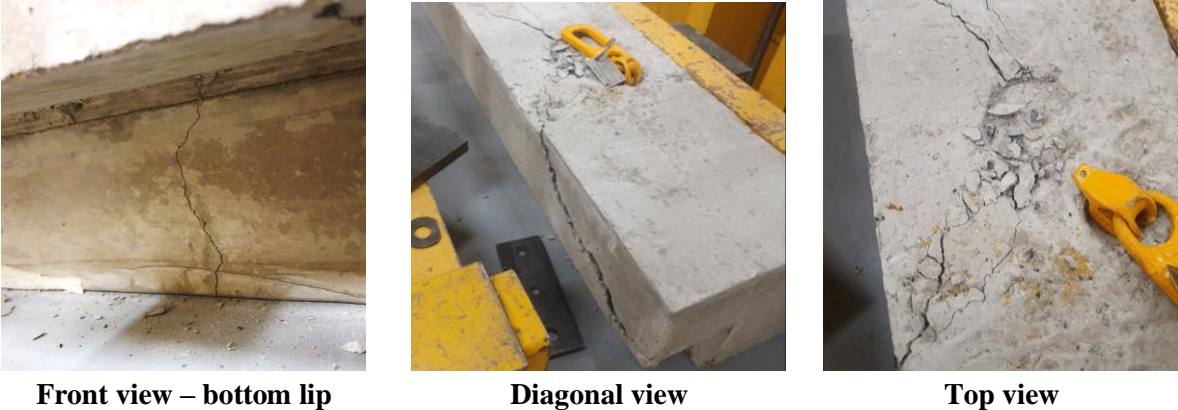
The test exhibited a failure value of 161.73 kN, which was higher than expected as shown in Figure 24. Adjusting this value to what would be expected at a 20 MPa concrete beams gives 133.9 kN. This beam failed via punching shear, however it was observed to be a result of local crushing. It should also be noted that a flexural crack was observed on the underside of the beam after testing, however it was unclear when this formed or its impact. The local crushing caused the pile to re-position at a non-perpendicular angle to the beam, inducing the punching shear failure (illustrated in Figure 23). In

Figure 23. Test 4 observed failure

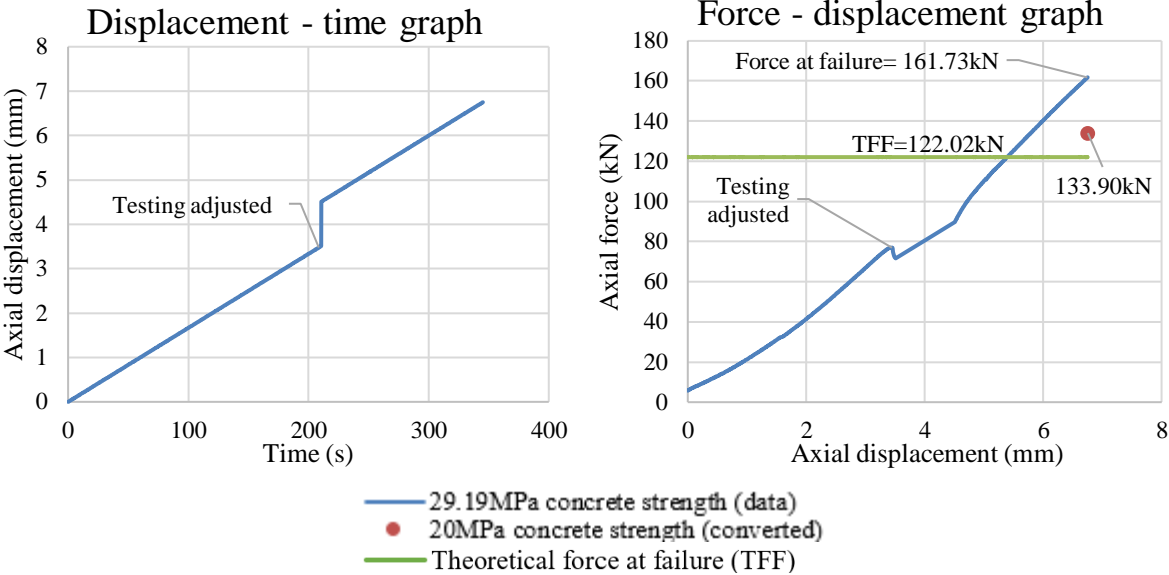
Figure 24. Test 4 (no eccentricity) graphical data

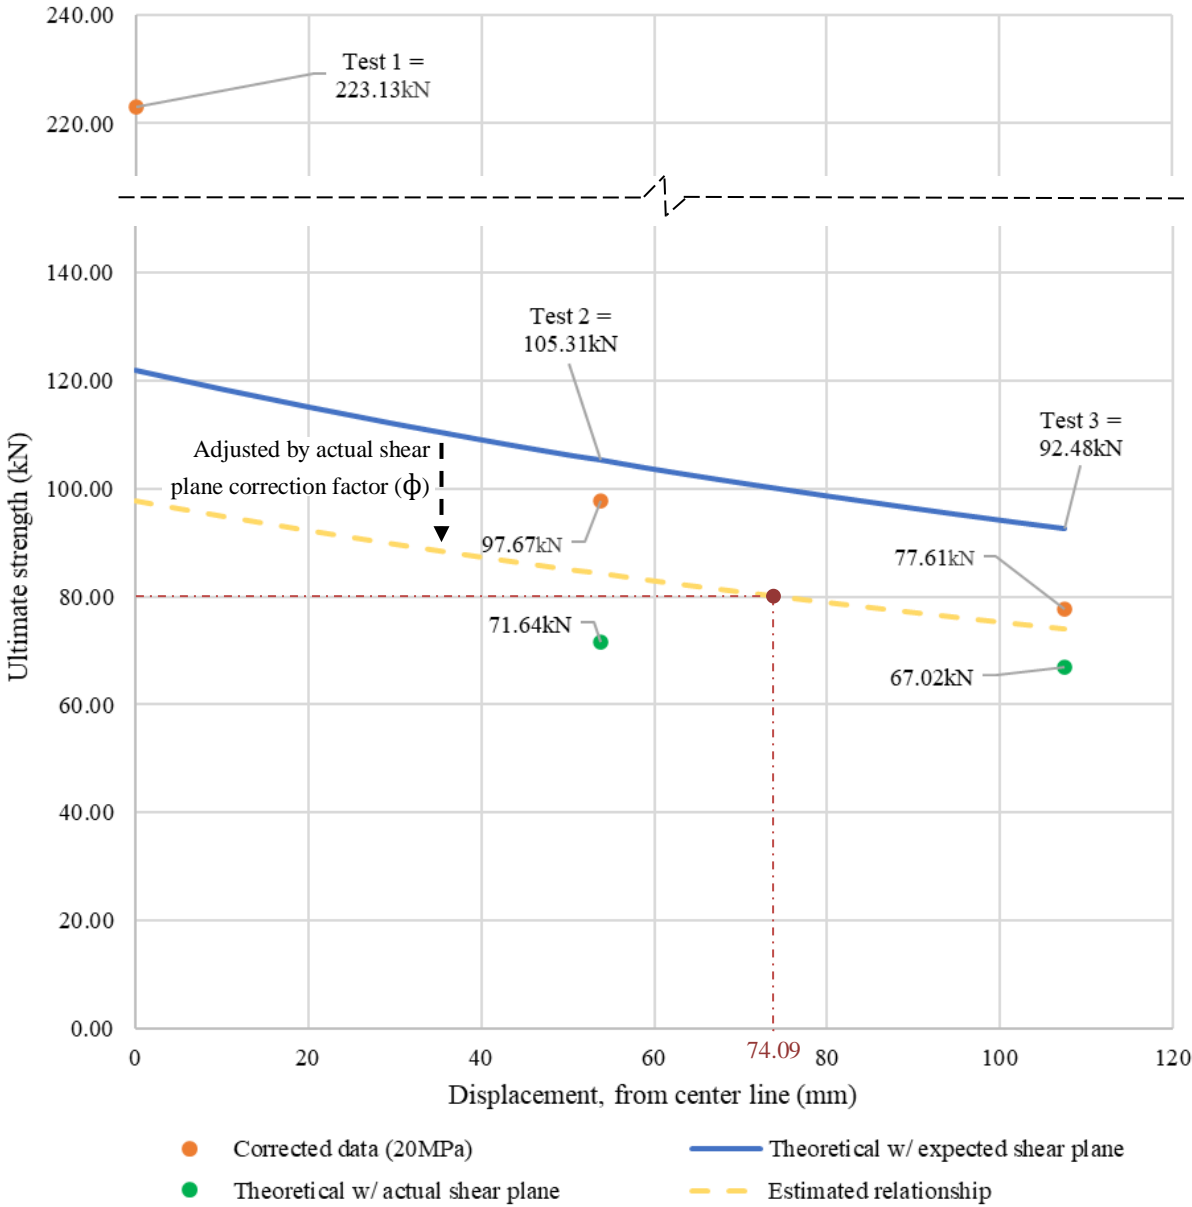
Punching shear is the predominate failure mechanisms observed. Thus, while the applied method of punching shear failure calculation overestimates the failure force (see Figure 25), test 1 and 3 exhibit a similar factor (17.48 % and 7.44 %, respectively) of difference. Between these bored pile locations, a hyperbolic relationship would be expected between the failure force and eccentricity based on their relationship in the punching shear failure equations (2) and (3), with some additional factor of discrepancy to ensure it is conservative. Due to the declining failure force with increasing displacement from the observed data alone, it is deduced that the SWL of the pile will be reached up to a displacement of at least 53.75 mm (test 3). While there is a large increase in the failure force in the

Figure 25. Failure force vs displacement (eccentricity) comparisons

The data obtained from the actuator is plotted, ultimate strength standardised to 20 MPa concrete strength (refer to Appendix F for laboratory observations). Comparisons are then made between the theoretical and observed failure, the data of which is summarised in Table 2 and Figure 25.

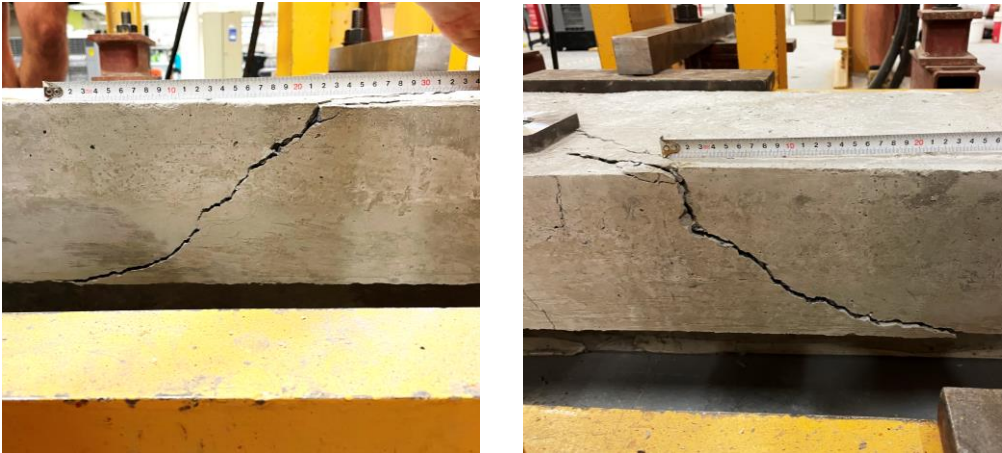
Figure 28. Measured front face of shear failure plane for test 3

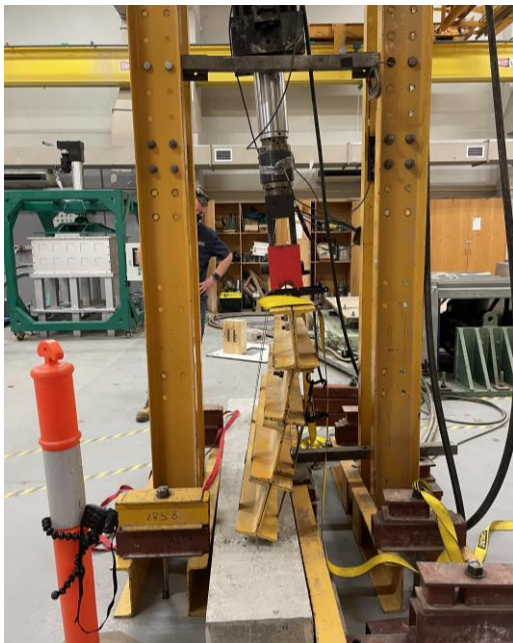
The experimental setup during test 2, which consisted of 3 I-beams strapped together underneath the actuator (shown in Figure 29), flexed considerably with the load veering off the vertical alignment. This unfortunately meant that the testing had to be paused and readjusted multiple times with steel beams placed to restrain the actuator. While this didn't necessarily have a prominent effect, as the testing location featured zero eccentricity, this issue needed to be mitigated in future tests. To rectify this issue, the steel I-beams were replaced by a block of cross-laminated timber, which mitigated deviation in the load path. An additional bolt from the actuator to the frame provided further restraint.

Flexure in system

Temporary mitigation strategy

Figure 29. Test 2 setup – flexure in system and mitigation

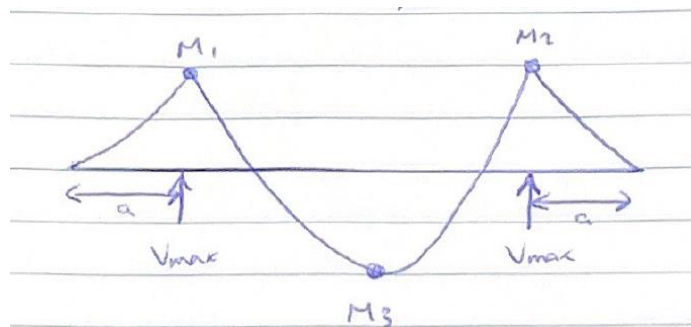
As shown in Figure 34, $M_1 = M_2$, which is given by (13).

Figure 34. Bending Moment Diagram
